Release Notes
ABS CSR SafeShip for Tankers
Release 6.8
Patch 3, 12 October 2006

ABS CSR SafeShip for Tankers Release 6.8 corresponds with the following version of the Rules:

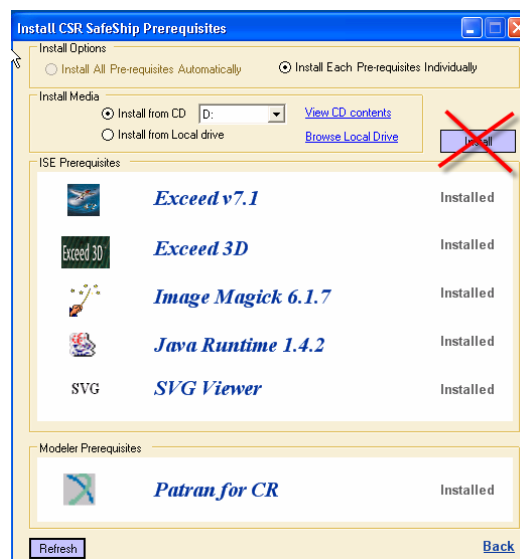
1. During the installation of software prerequisites the components should be individually selected for installation. The first "Install" button as shown below should not be utilized.
